**BULLETIN OF THE
SERVICE CITIZENS OF DELAWARE**

**GENERAL REPORT ON
SCHOOL BUILDINGS AND GROUNDS
OF DELAWARE**

OCTOBER 15, 1919

**GENERAL REPORT
ON SCHOOL BUILDINGS AND GROUNDS
OF DELAWARE
1919**

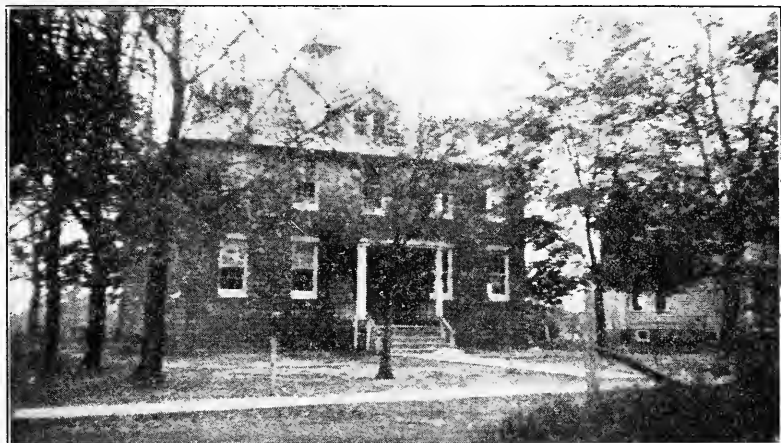
CHESWOLD NO. 83

Score	Perfect Score
I. Site	65	160
II. Building	98	200
III. Service Systems.....	43	250
IV. Class Rooms.....	111	225
V. Special Rooms.....	5	165
	<hr/> 322	<hr/> 1000

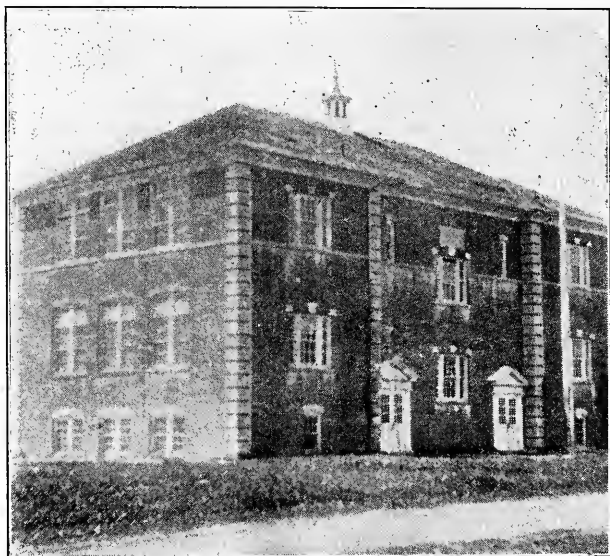
GREENWOOD SCHOOL

The Greenwood building is a six-room, two-story brick structure, built in 1915. It is rectangular in type, with a shingle roof and concrete foundation. In external appearance it is an attractive building, but the grounds have not been improved and nothing has been done in the way of planting shade trees or shrubbery which would improve the environment. The site is unusually large for school buildings in Delaware, but still under standard size. It is, however,

direct system of heating has been installed, with the boiler located in the basement. The radiation is apparently adequate, but no provision for ventilation has been made.

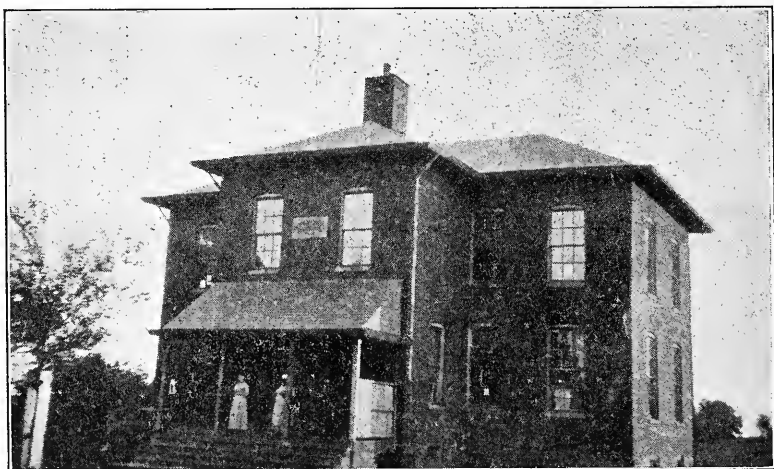
NEWPORT SCHOOL

Class rooms are slightly under size and do not conform to standard, but for comparatively small classes will serve adequately. The glass area is up to standard, but the windows are distributed so as to supply light from three sides.

The auditorium, which has the possibilities of use as a community room, is made ineffective by the placement of permanent seats facing each other in the two rooms, which can be thrown

together by a movable partition. In order to take full advantage of the opportunities offered by this room, movable type of seats should be employed. Two playrooms in the basement of the building were being finished at the time of the survey. These rooms, though poorly lighted, will make a distinct contribution to the usefulness of the building.

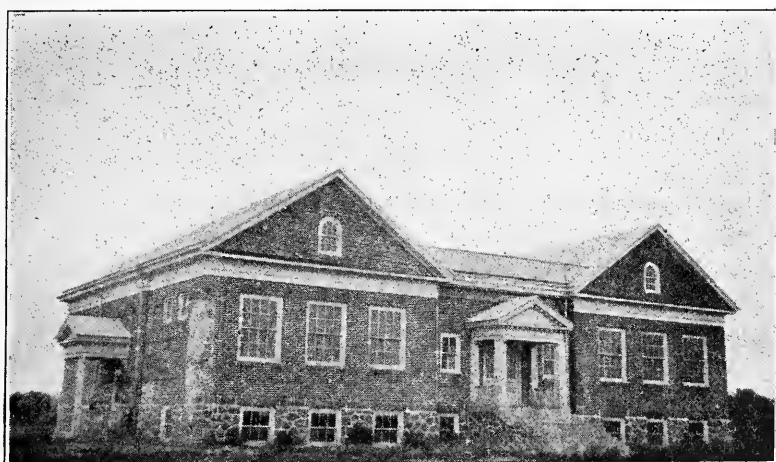
OAK GROVE SCHOOL

The building, being new, is in excellent condition and evidences good material and good workmanship throughout its entire construction.

tion. It is heated by direct steam, but no provision has been made for forced ventilation. Class rooms and corridors are lighted by electricity, but the number and arrangement of outlets are not sufficient to entirely meet the needs of the building for evening use for school purposes. Adequate provision is made for drinking facilities, but the number of wash basins is below standard and no provision is made for bathing. Indoor toilets, adequate in number, well fitted up, and especially clean and sanitary, were found in this building. In this respect the building stands out in marked contrast to almost every other school building in the State.

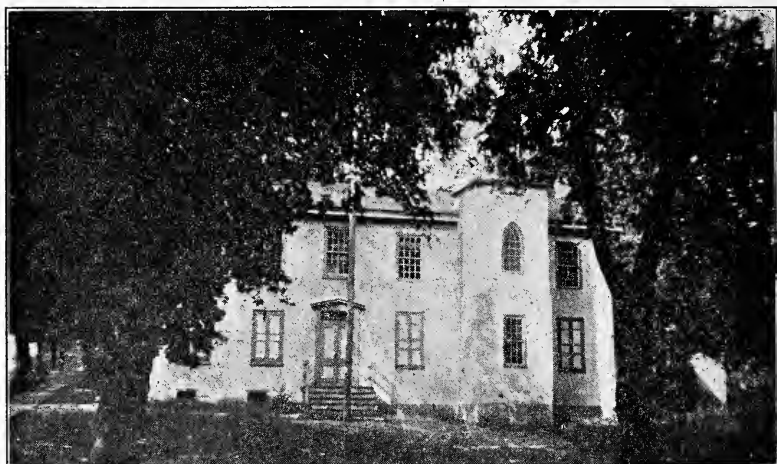
ODESSA SCHOOL

needs for which it was built, it has outlived its usefulness as a school building and should be closed for such purposes.

unusually beautiful by the large number of old maple trees that cover it. It seems a fitting suggestion that this grove be retained as a public park for the village and that a new and adequate school site be selected.

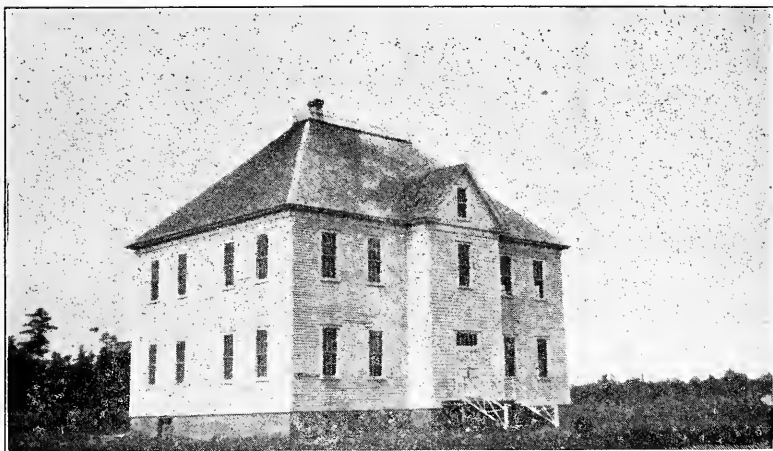
SELBYVILLE NO. 32, 108

Score	Perfect Score
I. Site	75	160
II. Building	79	200
III. Service Systems.....	63	250
IV. Class Rooms.....	123	225
V. Special Rooms.....	7	165
	<hr/> 347	<hr/> 1000

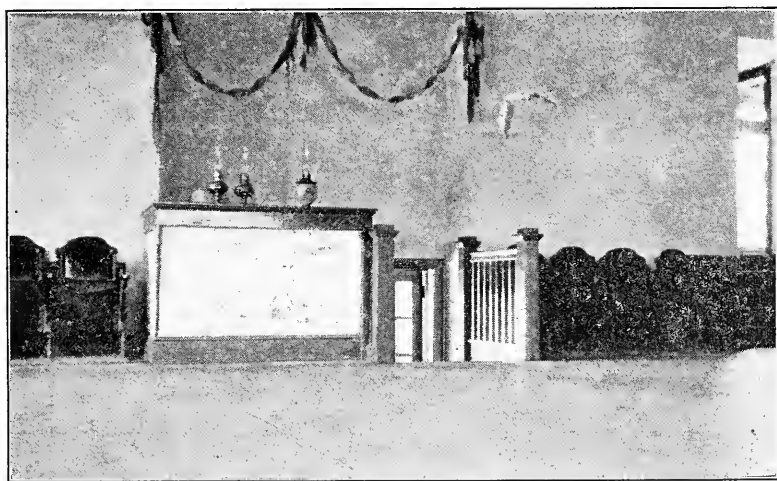
Special rooms. Full credit was given for the auditorium, as it represented an earnest effort on the part of the community to provide a good school and community assembly. The one most serious objection to this room is the absolute inadequacy of the exit. The room will seat comfortably 250 people, and the only means of entrance or exit is by means of a stairway, 39 inches wide, located in the center of one side of the room. A fire or panic in the auditorium would result in the death of a great many people. The auditorium should not be used for any purpose until adequate fire escapes are placed on the building, the same having doors cut to the floor level and provided with panic bolts.

THE ONLY EXIT FROM THE AUDITORIUM OF THE
TOWNSEND SCHOOL

This room, with a seating capacity of 250, is located on the second floor. The exit shown in the picture is 39 inches wide, and through it lies the only means of escape. It was stated locally that it takes from twenty to thirty minutes to empty a "packed hall."

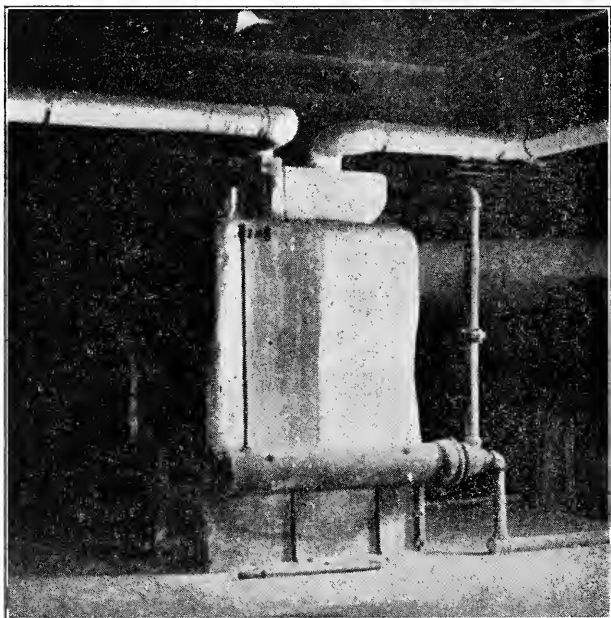
THE HEATING PLANT, SHOWING THE EXPOSED WOODEN
JOISTS DIRECTLY UNDER THE STAIRWAY

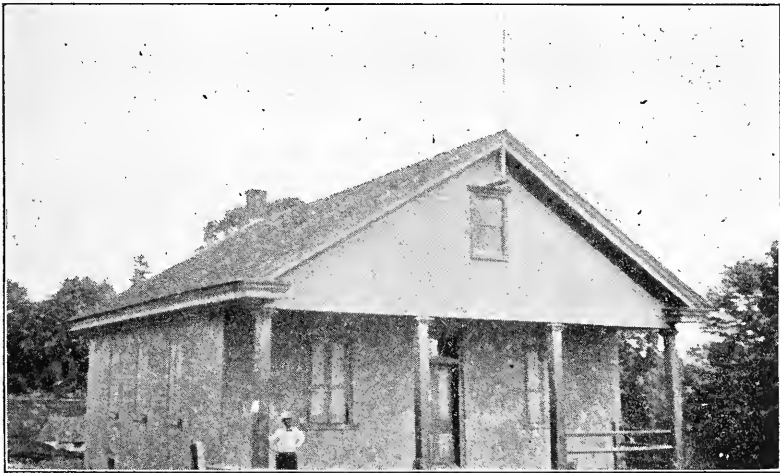
CLINTON, DISTRICT NO. 28

Score	Perfect Score
I. Site	71	160
II. Building	63	200
III. Service Systems.....	50	250
IV. Class Rooms.....	125	225
V. Special Rooms.....	3	165
	<hr/>	<hr/>
	312	1000

The Clinton School is a one-room, cobble-stone structure, 30x33 feet in dimension, standing on a site 150 feet square. It presents a very unattractive external appearance, looks timeworn and gloomy. The addition of a full-length porch in front of the building and the partitioning off of cloak rooms at the entrance has added materially to the usefulness of the building for school purposes. It is, however, both with respect to site, location and building, impossible of adaptation to modern school requirements and should, therefore, be disposed of for some purpose other than that for which it was long ago constructed.

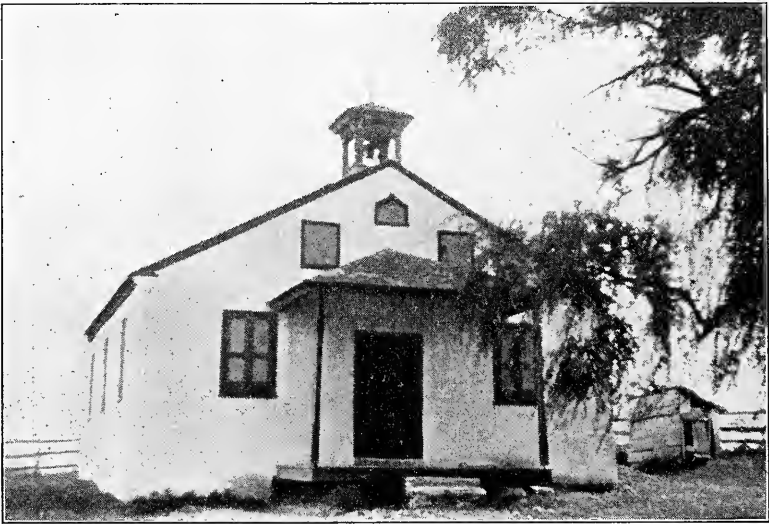
NORTH STAR, DISTRICT NO. 30

Score	Possible Score
Site	95	160
Building	79	200
Service Systems.....	43	250
Class Rooms	85	225
Special Rooms.....	1	165
	<hr/>	<hr/>
	303	1000

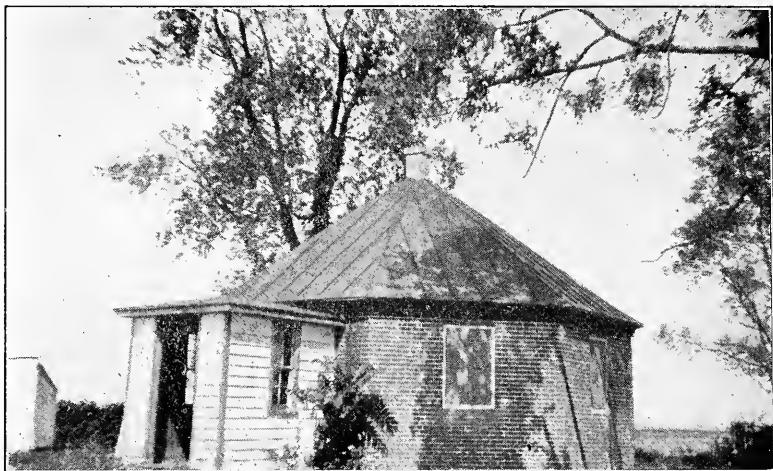
EIGHT SQUARE SCHOOL

As a monument to a bygone age in education, "Eight Square" is a most interesting type of building. At a time when it was considered essential to one's educational development that he be within easy reach of the master's rod, an octagonal room may have had peculiar advantages, but in the present era, when the angle at which the light falls upon the pupil is regarded as more important than the angle at which the rod falls, Eight Square is out of place as a school building.

The scores indicated above point to a very certain condemnation of the building on every major item of consideration. Reference to the detail score, will show that the environment of the build-

ing is the only commendable feature which it possesses. Because of its lighting features alone, if for no other, it should be closed for school purposes.

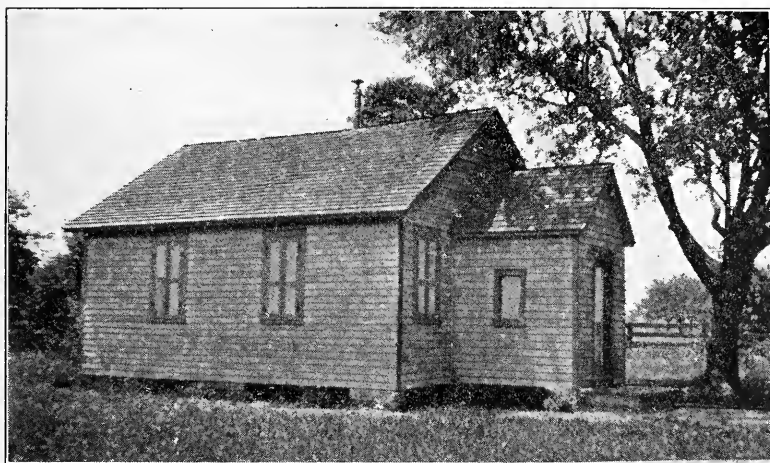
JAMISON'S CORNER SCHOOL

Score	Possible Score
I. Site	100	160
II. Building	75	200
III. Service Systems.....	40	250
IV. Class Rooms.....	103	225
V. Special Rooms.....	2	165
	<hr/> 320	<hr/> 1000

The slightly higher score of this building is due not so much to the building itself as to the fact that good roads make it accessible and that there is some evidence of effort to improve the environ-

ment. A painted fence in good condition adds much to the general appearance. The building is so small and so nearly square that the problem of heating becomes very serious. As the seats are located and the stove placed, children are compelled to sit within 16 inches of the fire bowl of the coal stove that occupies the center of the room. Twelve new adjustable single seats and an excellent teacher's desk adds to the appearance of the equipment, but the fact that the room is lighted from three sides and that it does not qualify in any major items of consideration condemns its further use.

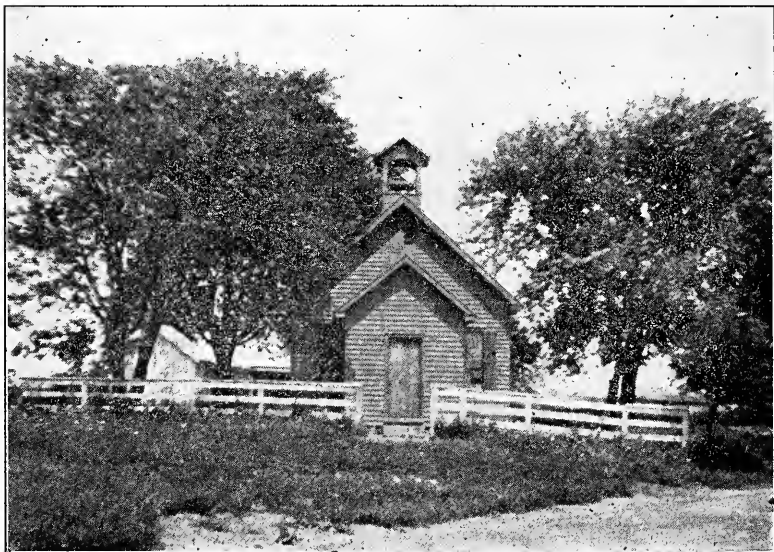
HICKORY GROVE SCHOOL

Almost in the shadow of this flag stands the Hickory Grove School that scores, in point of adequacy, 328 points out of a possible 1000. No flag floats over it, nor has any provision been made that it might do so. A meager little site, the size of a town lot, offers little opportunity for the recreational needs of the children. The classroom is lighted from three sides and heated by a stove placed in the center of the room

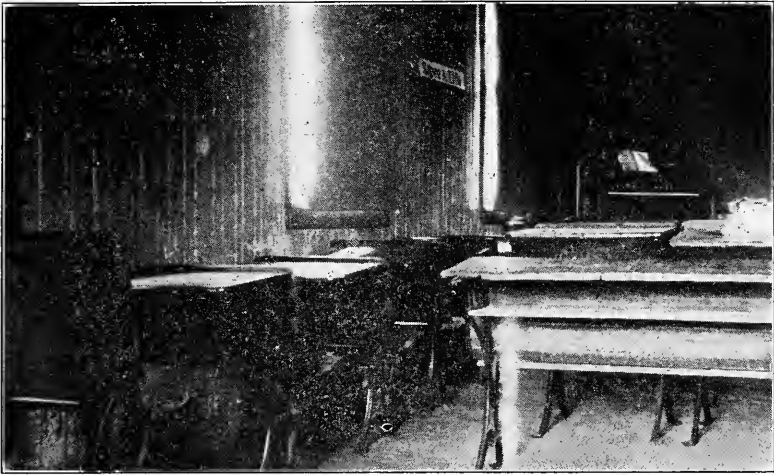
BLACKBIRD, DISTRICT NO. 69

Score	Possible Score
I. Site	55	160
II. Building	51	200
III. Service Systems.....	15	250
IV. Class Rooms.....	65	225
V. Special Rooms.....	1	165
	<hr/> 188	<hr/> 1000

Building. Small, very old and in a deplorable state of repair.

of the room; makes no provision for drinking and washing. The toilet facilities are of the poorest type and in bad condition. The room is lighted from four sides.

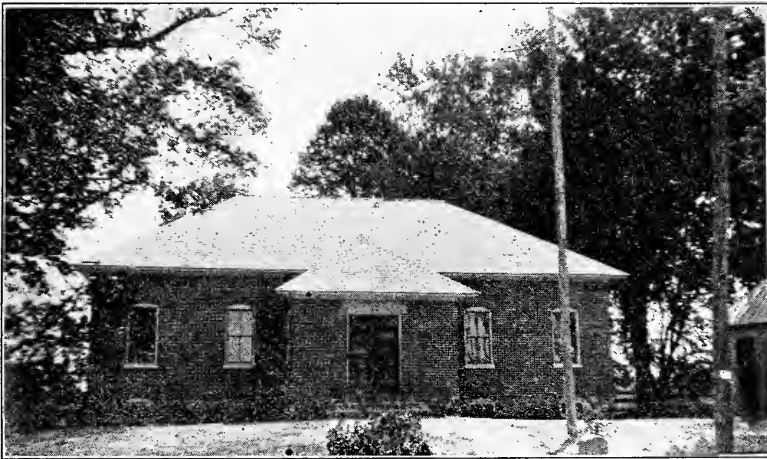
SHARPLEY, DISTRICT NO. 7

Score	Possible Score
I. Site	113	160
II. Building	138	200
III. Service Systems.....	54	250
IV. Class Rooms.....	125	225
V. Special Rooms.....	3	165
	<hr/> 433	<hr/> 1000

Class rooms are approximately standard in size, but not arranged to best advantage. The glass area is sufficient, but the window placement is extremely bad, the light being admitted from three sides. Desks and other equipment are of slightly better quality and in better condition than buildings of corresponding type in the State.

Under the proposed plan of consolidation, it seems advisable that this building be disposed of and the children that normally attend here be transported to a consolidation center in the vicinity of Tallyville. The roads and number of pupils to be accommodated in such a center make the problem comparatively simple and entirely practicable.

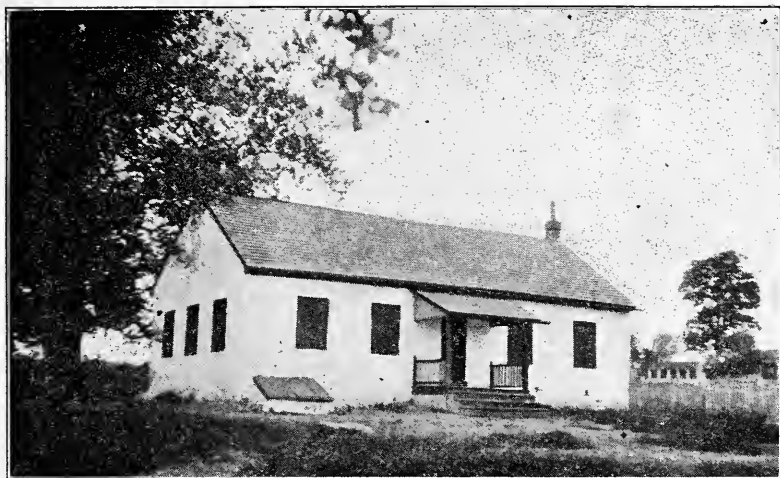
ROCKLAND, DISTRICT NO. 8

Score	Possible Score
I. Site	110	160
II. Building	93	200
III. Service Systems.....	53	250
IV. Class Rooms.....	107	225
V. Special Rooms.....	3	165
	<hr/> 366	<hr/> 1000

In the light of the new educational program in the State of

Delaware, this building should be abandoned for school purposes, and the children heretofore attending this school should be transported to the proposed large consolidation near Tallyville.

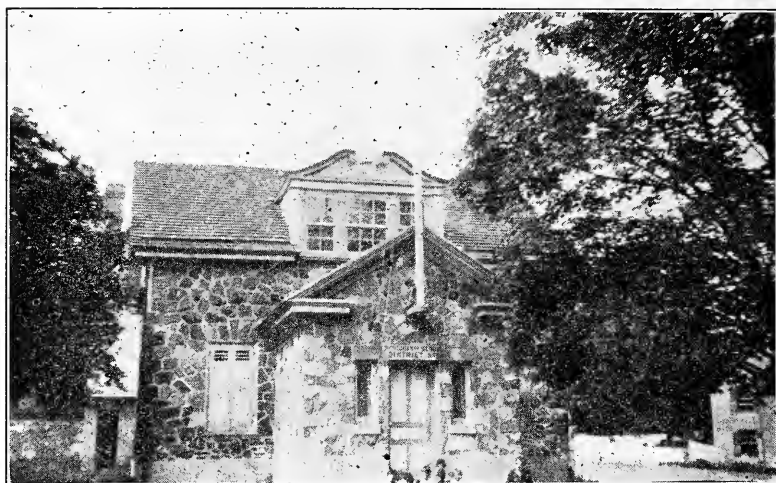
MONTCHANIN, DISTRICT NO. 24

Score	Possible Score
I. Site	83	160
II. Building	110	200
III. Service Systems.....	83	250
IV. Class Rooms.....	92	225
V. Special Rooms.....	4	165
	<hr/>	<hr/>
	372	1000

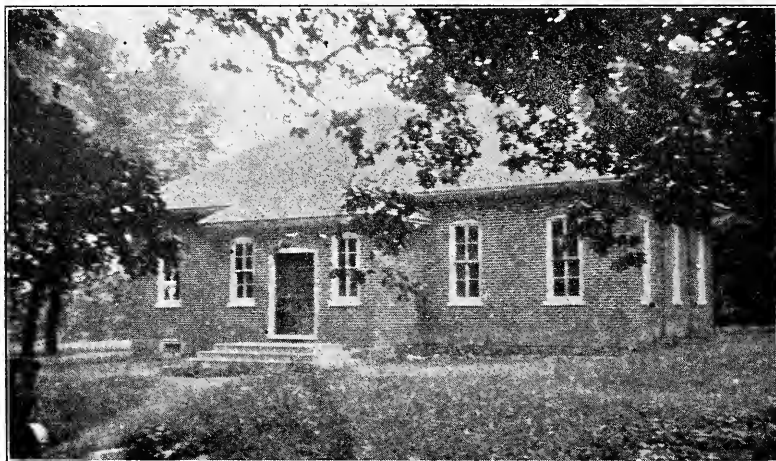
BRANDYWINE SPRINGS SCHOOL

This is a new one-story, two-room, brick building, located on a somewhat larger triangular site than is commonly allotted to rural school buildings in the State of Delaware. The site is joined on one side and in the rear by dense woods and has not been improved or developed for recreational purposes in any way. The building is, however, in good condition and possesses the possibilities of being

made into an excellent two-teacher, six-year school. In order for this building to meet the standards required for such a school, and in order for its score to be made acceptable, it will be necessary for the present site to be materially extended, developed and improved. Playground and recreational apparatus should be installed; the outdoor toilets should be done away with, and space be provided inside for water-flush or chemical toilets.

A direct steam-heating system has already been installed in this building, and with the addition of adequate artificial light and a water supply system, together with the proposed inside toilets, the score on service systems would approach a satisfactory minimum.

The class rooms, although better in many respects than those found in the older buildings, still do not recognize the importance of the best light—the light now being admitted from three sides. This error should be corrected if the building is to be continued in service.

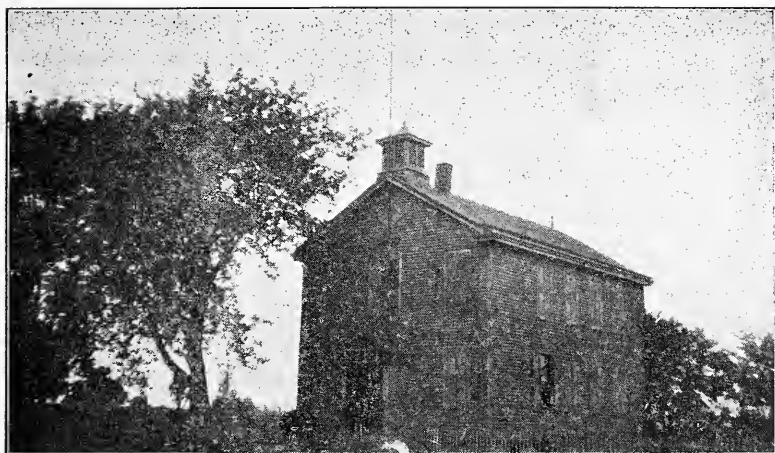
ST. GEORGE'S, DISTRICT NO. 53

Score	Possible Score
I. Site	95	160
II. Building	55	200
III. Service Systems.....	51	250
IV. Class Rooms.....	153	225
V. Special Rooms.....	4	165
	<hr/> 358	<hr/> 1000

The St. George's School is a very old, two-room, two-story, frame structure, with tin roof and brick foundation, located on a site approximately 180x120 feet. The site is too small to meet the needs of this rather large group of children, and because of adjoining village residences; the site is difficult of adequate expansion.

It is not consistent with the modern educational policy that the children of this community be housed continuously in a building

which provides nothing more than is possible in this structure. It should, therefore, be disposed of and a plant adequate to the needs of the community and large enough to justify a complete educational-recreational program supplied.

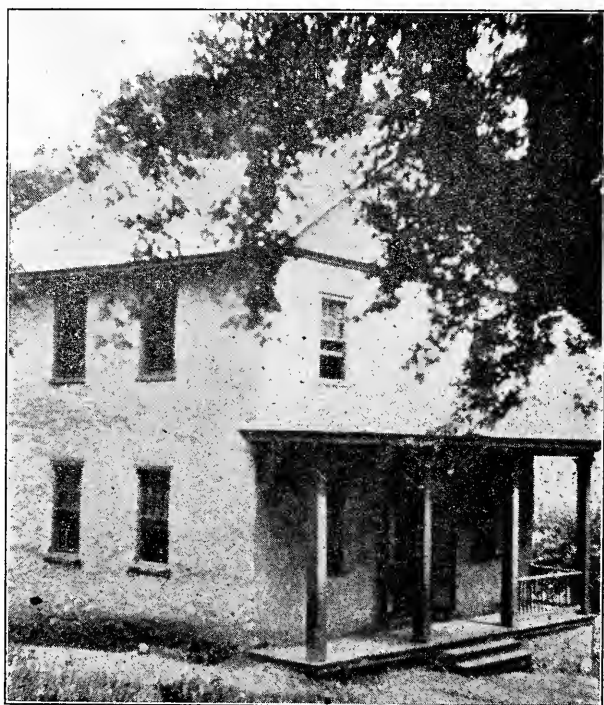
YORKLYN, NO. 91

Score	Possible Score
I. Site	78	160
II. Building	83	200
III. Service Systems.....	71	250
IV. Class Rooms.....	129	225
V. Special Rooms.....	10	165
	<hr/>	<hr/>
	371	1000

The Yorklyn School is housed in a very old two-room, two-story brick and plaster structure located on the side of a steep hill and surrounded by many large, beautiful old trees. More by way of commendation can be said of the trees than of any other part of the school plant. The site, because of its location on the side of a hill, is impossible of use in the development of a recreational and educational program. The building was constructed long before any notion of educational standards in building construction had been developed. In the light of this fact, the building is entirely inadequate for modern needs, and as a school building it should be closed. The building does, however, have to its credit a system of direct heating and an inside water supply system, with drinking fountain, has been installed. The toilets are located on the high ground above the building, but some measure of protection has been taken by the construction of fairly adequate toilet vaults. The Yorklyn district cannot afford, from an educational point of view, not to seriously consider the consolidation of their district with that of Hockessin and two or possibly three other neighboring districts, for the purpose of constructing a large educational center at some point conveniently located with respect to the districts concerned.

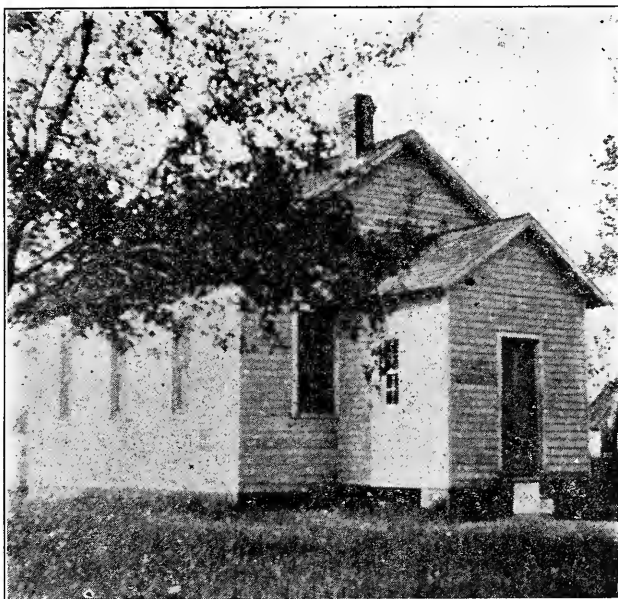
BLACKISTONS NO. I

Score	Perfect Score
I. Site	75	160
II. Building	67	200
III. Service Systems.....	67	250
IV. Class Rooms.....	87	225
V. Special Rooms.....	2	165
	<hr/> 291	<hr/> 1000

This school building is a one-story frame structure that was built in 1881. It may have answered the demands of education at that time, but recent years have seen rapid progress in the requirements upon rural school buildings. It is, therefore, imperative that if the district of Blackistons is to keep pace with educational progress it is necessary for it to abandon this building and construct a new one. The service systems and equipment are in keeping with the rest of the building and should be cast aside at the same time as the rest of the building.

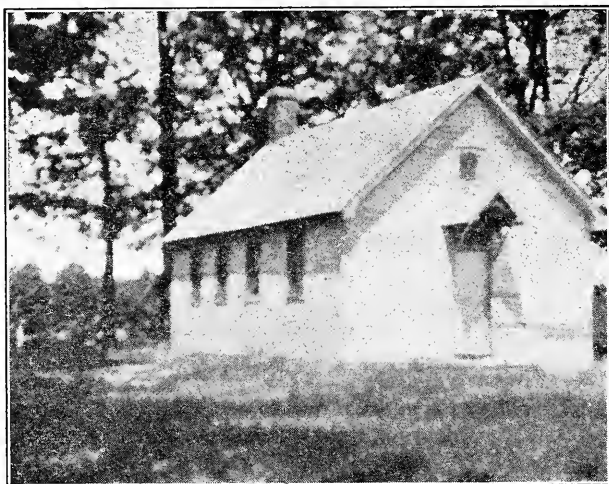
FAIR VIEW NO. 15

Score	Perfect Score
I. Site	95	160
II. Building	54	200
III. Service Systems.....	63	250
IV. Class Rooms.....	82	225
V. Special Rooms.....	0	165
	<hr/>	<hr/>
	296	1000

This building is a one-room, rectangular frame structure, located on a site 100x150 feet in a beautiful grove of oak trees, surrounded by open fields. The site, except for size, is the most commendable feature of the plant. Little attention has been given to the comforts and the physical needs of the children, and the class room is extremely poor. As typical evidence of this neglect it was noted by the Commission that the only blackboard area in the class room was placed in the rear of the room. Similar lack of foresight and knowledge of educational needs is evidenced throughout the plant. Should this location be agreed upon as the logical one for a school building, the present site should be extended to include a number of acres of the adjoining fields and the grove preserved as a school park and a community ground.

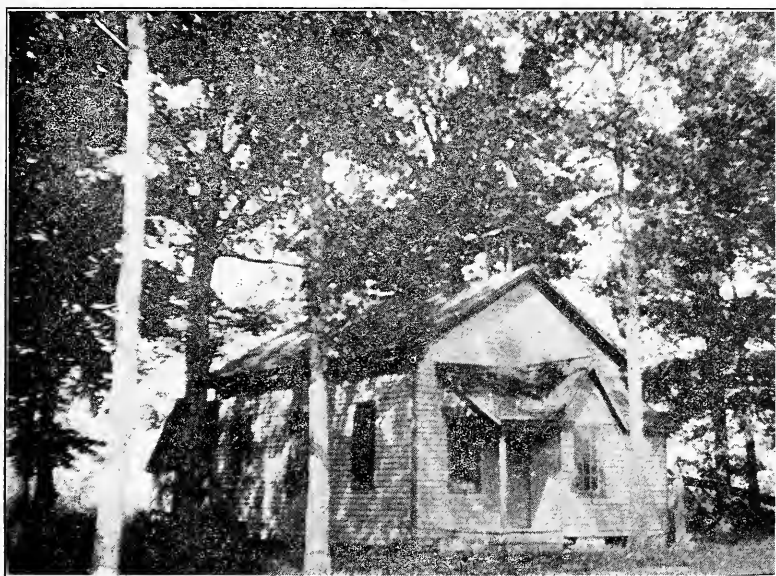
FOREST LANE NO. 104

Score	Perfect Score
I. Site	70	160
II. Building	60	200
III. Service Systems	46	250
IV. Class Rooms	70	225
V. Special Rooms	2	165
	<hr/> 248	<hr/> 1000

The only commendable feature of this building is the beautiful grove of trees in which the building stands. This feature would be extremely desirable were the site extended to include the cleared space upon which recreational activities of the school children might be had. In the present situation, however, there is little room for games of any sort. The building is heated by a box wood stove, and all of the equipment and facilities in and about the building evidence the most abject poverty conceivable. In the opinion of the Survey Commission there is no justification in compelling children, under penalty of the law, to attend a school building which provides nothing more than is found in this building. It should be abandoned for school purposes.

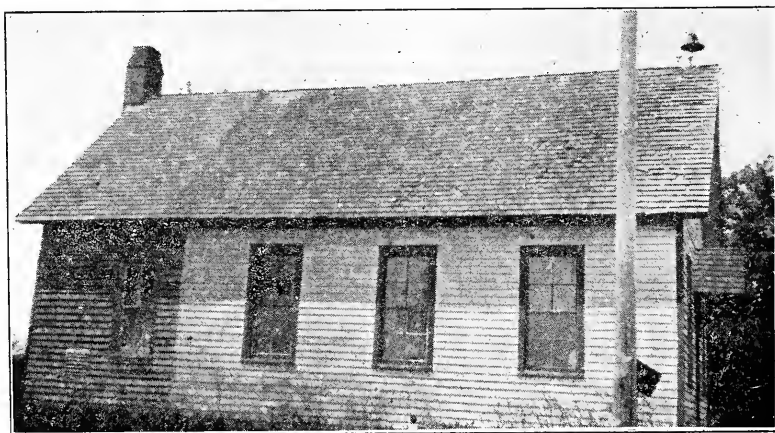
MARYDEL NO. 115

Score	Perfect Score
I. Site	62	160
II. Building	74	200
III. Service Systems	73	250
IV. Class Rooms	105	225
V. Special Rooms	3	165
	<hr/> 317	<hr/> 1000

The Marydel school is a rectangular, one-room, frame building, 18x33, located on a site 60x100. The site is located on the top of a knoll which slopes off abruptly into marshy ground in three directions, thus making it impossible of extension or adaptation to school needs. The building is very old and in poor state of repair. The class room is slightly better than that in other buildings of its general type, but scores only 105 out of 225 points. Building and site should be abandoned for school purposes.

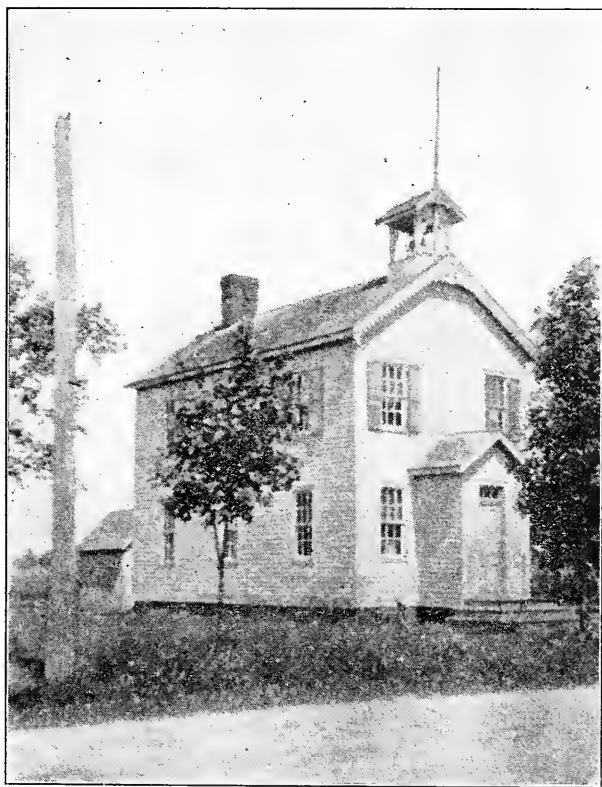
HARTLY SCHOOL

The Hartly School is housed in a very old two-story, two-room, frame building, in poor condition. The building is located on a very undesirable, unattractive site. The improved type of heater, thirty-eight new single seats and the good pictures which have been secured for the building represent its only commendable features. The number of children in attendance at this school would seem to justify the recommendation that a more adequate provision be made for a modern educational program.

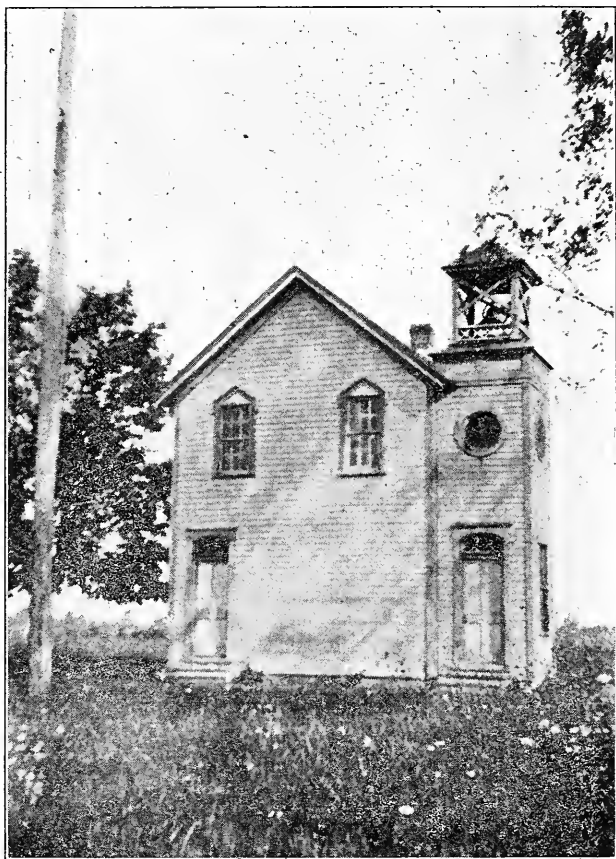
CANTERBURY SCHOOL

This two-story, two-room structure is located on an open rectangular lot which can be used for play purposes. The interior of the building would be a disgrace to any community. Plaster has been broken from the walls in many places; blackboards have been

torn down; furniture roughly treated, and the roof has leaked in places. Apparently no respect is paid to public school buildings by

the school children of this community, and probably this building with its equipment and cheap construction is entitled to little respect. The building has no attractive feature about it.

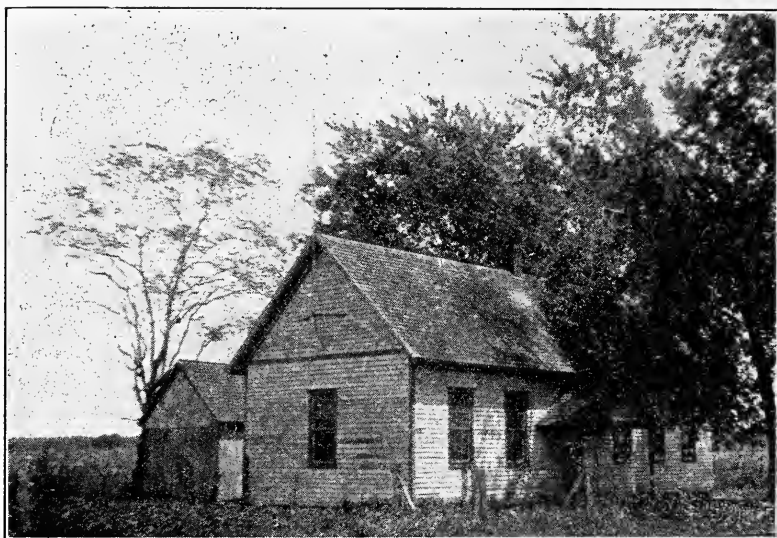
BETHESDA NO. 46

Score	Perfect Score
I. Site	80	160
II. Building	67	200
III. Service Systems	39	250
IV. Class Rooms	105	225
V. Special Rooms	4	165
	<hr/> 295	<hr/> 1000

This is a two-room, one-story, frame building, located on a triangular site, the base of which is 100 feet, and the length of which is approximately 200 feet. The building is very old and poorly preserved. It offers the absolutely minimum of room space, and the service systems are of the lowest type which will permit of the assembling of children in groups. The class rooms are inadequately equipped, and the lighting arrangements are especially bad, one room being lighted from three sides. The fuel room, which from an educational point of view is perhaps the least essential, is the best feature of the building.

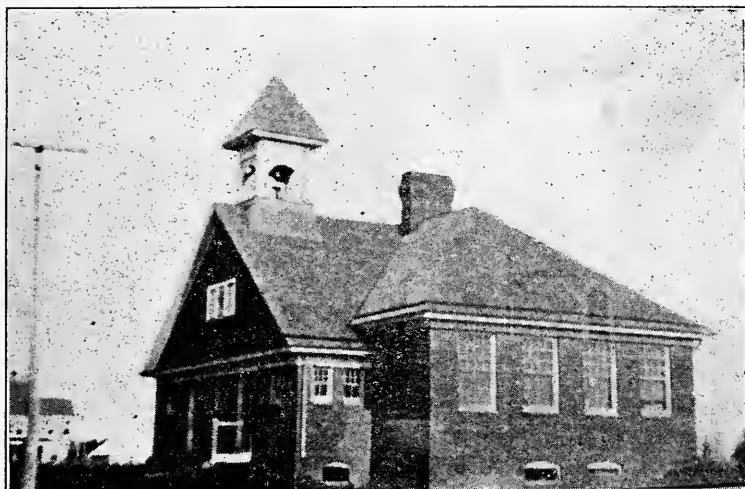
VIOLA NO. 112

Score	Perfect Score
I. Site	86	160
II. Building	117	200
III. Service Systems	91	250
IV. Class Rooms	132	225
V. Special Rooms	2	165
	<hr/> 428	<hr/> 1000

actual needs and is undeveloped for recreational purposes. The building is cheaply constructed and certain very fundamental errors are outstanding. The foundation walls are but eight inches thick, and standing as they do in soil that is partially quicksand the building has settled out of line and considerable damage has already been done to the walls and building.

The building is provided with inside chemical toilets, which are in fair condition and apparently sanitary. It is to be noted, however, that but one toilet is provided for each sex. This, for a school of two large rooms is not sufficient to meet the needs of the pupils. The only way in which this building can be made to approach acceptable standards is by considerable alteration and extension of the building proper and development of the site upon which the building stands.

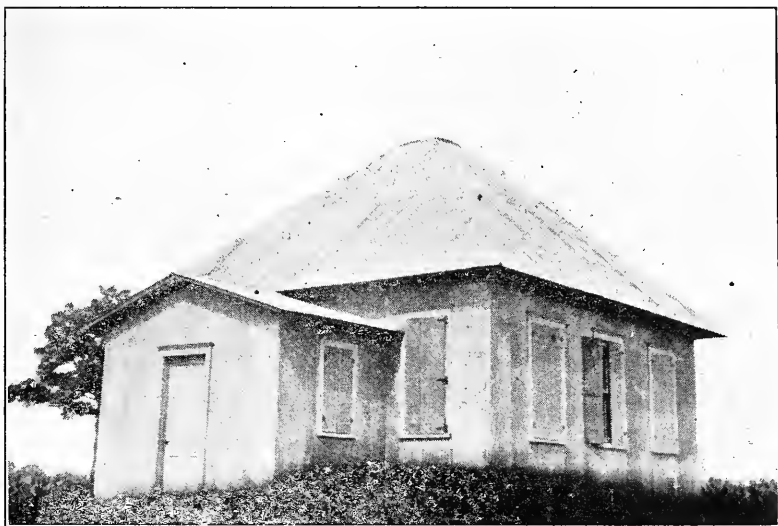
WHITES CHAPEL NO. 10

Score	Perfect Score
I. Site	97	160
II. Building	41	200
III. Service Systems	60	250
IV. Class Rooms	94	225
V. Special Rooms	2	165
	<hr/>	<hr/>
	294	1000

Whites Chapel is a new one-room structure, 20x22 in dimensions, with vestibule. It stands on a brick foundation. The site upon which the building is located is irregular in shape, approximately 100 feet in width and 300 feet in length. This building is a very unusual type of school building. It is made completely, walls and roof, out of corrugated, unpainted iron and resembles a garage rather than a place in which children are to receive their educational training. It does not speak well for the attitude of the community towards education or the welfare of their children. Apparently it is the cheapest type of construction which could be found. An improved type of heater is located in this building and water is supplied by a pump located in the vestibule. The class room, which seats 32 pupils, is entirely too small and of unapproved shape. The glass area is up to standard but distributed on three sides of the room. The vestibule provides space for cloak rooms, but as such is not acceptable.

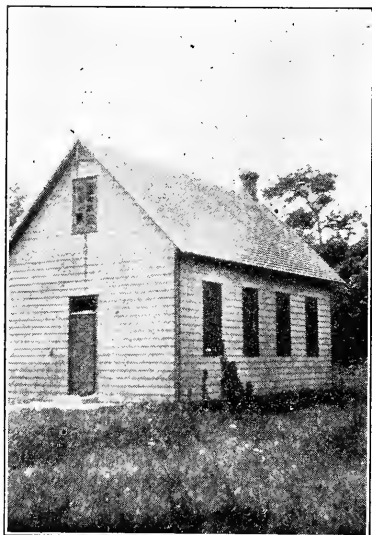
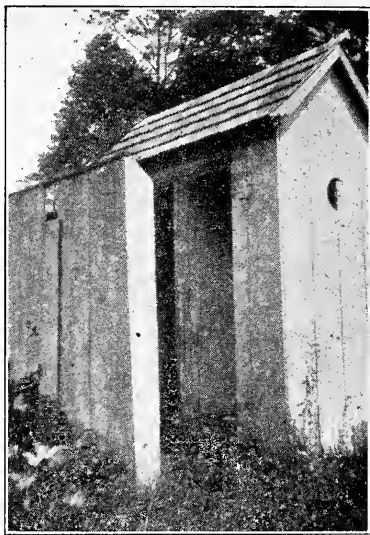
ELDORADO SCHOOL

This building, 18x28, situated on a site of indeterminate area, has concrete steps leading to its front door. The floor of this building is poor, the shades in bad condition but excellent book and sup-

ply closets are provided. Provisions for seating 40 children in double seats were found. The teacher's desk was of a fair type and slate blackboard is provided in sufficiency. No clock and no pictures were to be found. The building has a sufficient amount of window area, half of which, however, is in the wrong place. The only out-

house for this school is a combination of two compartments, separated by a wood partition, each one of which was apparently designed for the different sexes. That such a combination of outhouses is not a desirable method of raising the moral tone of children, nor of teaching them sex education was quite evident from the obscene drawings and foul language with which the interior of these outhouses was coated.

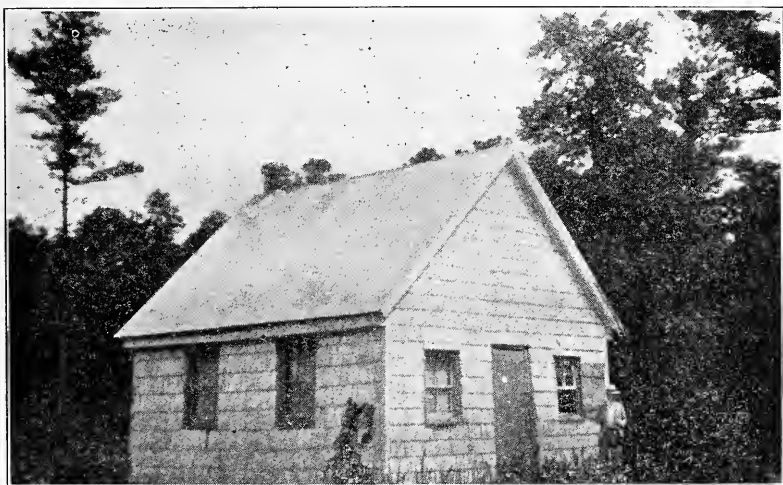
HILL'S NO. 21

Score	Perfect Score
I. Site	45	160
II. Building	35	200
III. Service Systems	30	250
IV. Class Rooms	48	225
V. Special Rooms	3	165
	<hr/> 161	<hr/> 1000

The Hill's school is situated in a little clearing with forest to the right, rear and front, and an open field to the left. It is a whitewashed, shingle structure which is decaying rapidly. It has a roof of corrugated metal and a foundation of rotting wooden posts. The room is square, being approximately 18 feet each way, and is lighted by two windows on each of three sides. Even though lighted on three sides and even though the room is small, these six windows do not furnish more than half of the percentage between the window area and floor area that is considered to be the standard. A box wood stove, without jacket, is located toward the front center of the room. The seats are placed on stilts and occupy a large part of the class room. The floor is in fair condition, but only a distance

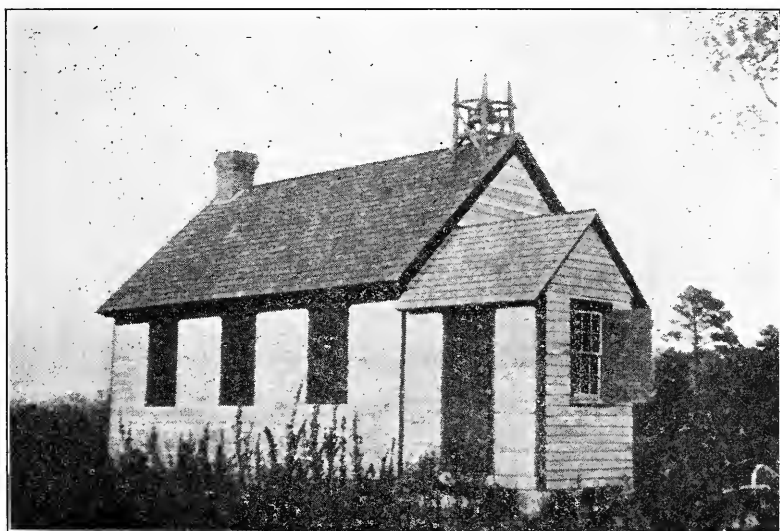
BETHANY BEACH NO. 28½

Score	Perfect Score
I. Site	35	160
II. Building	34	200
III. Service Systems	61	250
IV. Class Rooms	55	225
V. Special Rooms	2	165
	<hr/> 187	<hr/> 1000

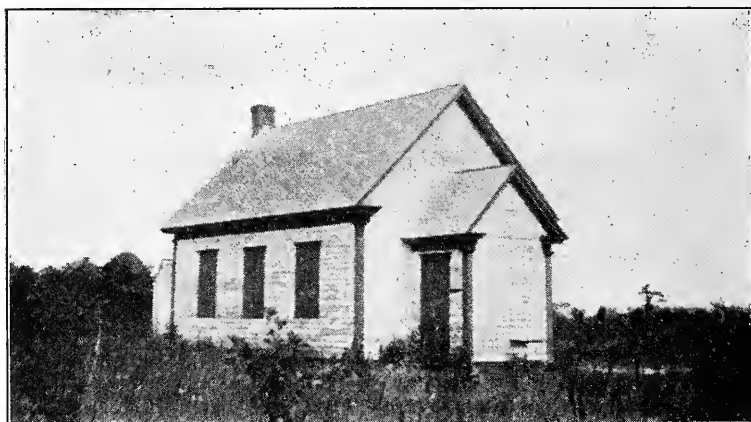
FAIRMOUNT NO. 82

Score	Perfect Score
I. Site	90	160
II. Building	65	200
III. Service Systems	55	250
IV. Class Rooms	115	225
V. Special Rooms	2	165
	<hr/> 327	<hr/> 1000

Fairmount is a one-room structure with a ramshackle exterior but fair interior. It is located on an unattractive piece of land at a point where it does not appear to be accessible to a large number of children. It has an improved type of heater, wainscoting and pine board ceilings, and fair children's seats, although they are of the double variety. The toilets are located directly in the rear of the building and in close proximity to one another, without any barrier.

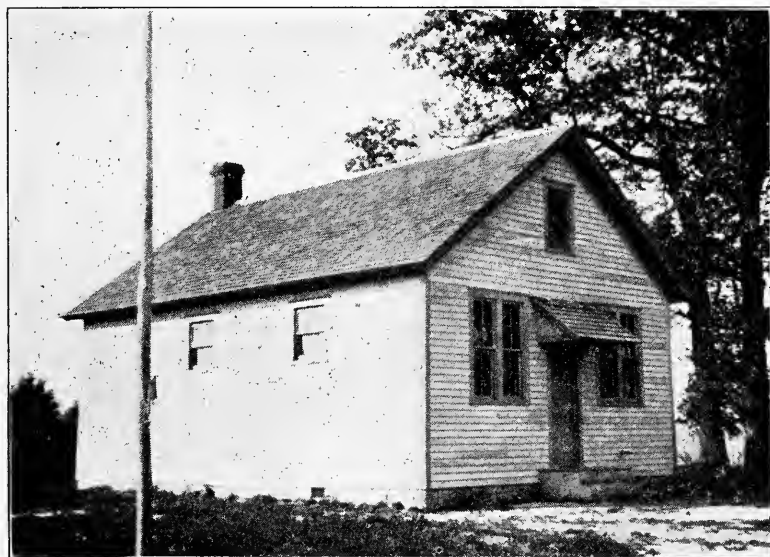
JOHNSON'S NO. 85

Score	Perfect Score
I. Site	97	160
II. Building	86	200
III. Service Systems	65	250
IV.. Class Rooms	141	225
V. Special Rooms	3	165
	<hr/> 392	<hr/> 1000

This school is a new one-room, frame building, 21x32, with concrete foundation and vestibule. It is located on a site approximately 100x150 feet, which is in good condition and well kept. The building is located on an excellent highway and is easily accessible. An excellent type of vestibule providing fairly satisfactory cloak rooms is included in the structure. The service systems, however, are much below the standard of the other features of the building. The class room is heated by a common stove. A pump is installed in the building. The outside toilets are in rather better condition and of better quality than found in other districts. The class room is the best feature of the entire situation. It is of good size and well shaped. Unfortunately the interior is finished in wood. This is not a standard type of finish. The blackboards are excellent and the glass area is adequate. The window area, in so far as the building plan is concerned, is not extremely bad. The windows have been banked on one side and three small windows have been placed high up on the opposite side of the room. These windows would not be seriously objectionable were it not for the fact that utter ignorance and stupidity have been shown in the arrangement of the seats. The seats and desks have been backed to the main source of light, thereby compelling the children to face all day long the two high windows in what has been made the front of the room. The seats should be turned in such a way as to place the main light source on the left of the pupils and the blackboards should be moved from the side of the room to the front. The seats and desks are of the single type of good quality and well selected as to size.

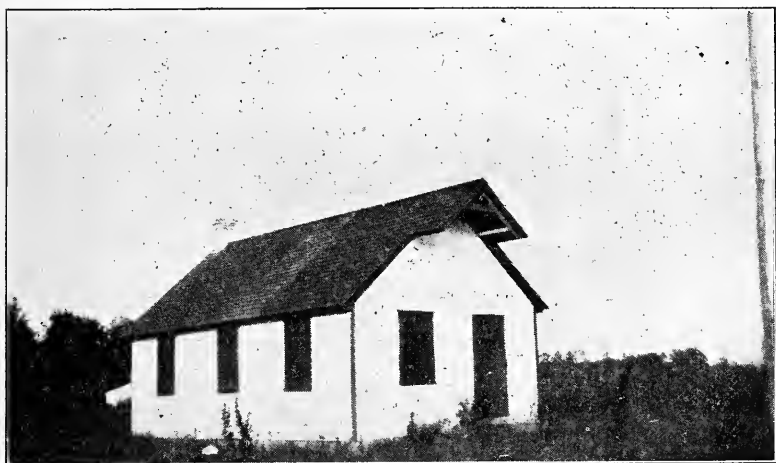
MUDDY NECK SCHOOL

Score	Perfect Score
I. Site	58	160
II. Building	36	200
III. Service Systems	46	250
IV. Class Rooms	70	225
V. Special Rooms	2	165
	<hr/>	<hr/>
	212	1000

This is a very old one-room, frame building, without vestibule or protected entrance. It is approximately 15x24 in dimensions, located on a triangular site, too small to allow for any recreational program. It is in very bad state of repair and presents every poor feature, from lack of service systems to lighting on three sides. The equipment is inadequate, the only feature thereof which is at all passable is the provision made by the installation of new double seats. Double seats, however, are not acceptable under modern educational standards. If consolidation cannot be effected for the children of this district a new one-teacher school, built on modern lines, should be provided.

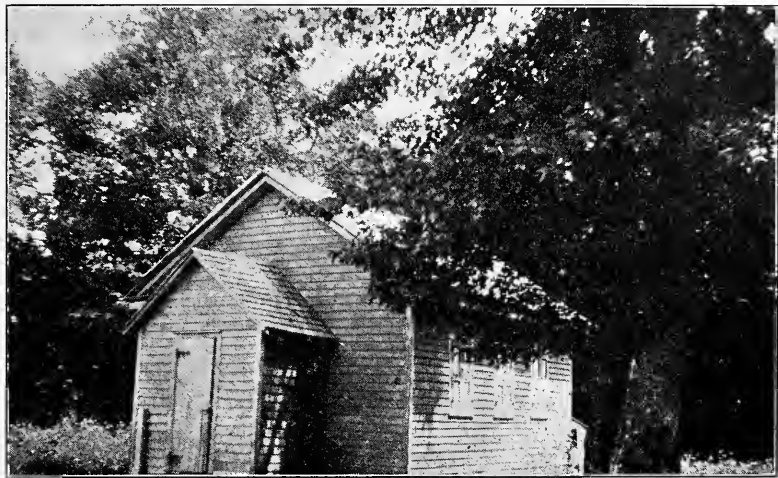
HOLLYVILLE SCHOOL

The building is 20 ft. long by 16 ft. wide and rests upon a brick foundation. It has a corrugated metal roof upon which the rain no doubt beats down to the disadvantage of school discipline. Two rows of single seats have been provided besides the double seats that are in use in this building. Apparently the only reason why single seats were provided was because the building was too small

for double seats, as the single seats have been placed against the wall even where the dead wall spaces are to be found between win-

dows. The building would make a fair sized woodshed but is altogether unsatisfactory as a schoolhouse. Its outhouses are in wretched condition and in close juxtaposition to each other and the school. One outhouse may be reached by wading through water at certain times of the year.

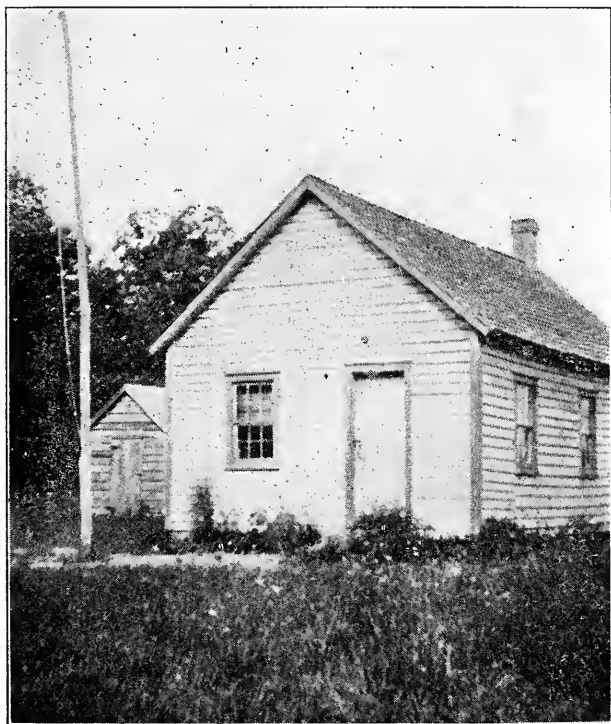
FOREST PARK NO. 179

Score	Perfect Score
I. Site	43	160
II. Building	29	200
III. Service Systems	34	250
IV. Class Rooms	56	225
V. Special Rooms	2	165
	<hr/> 164	<hr/> 1000

This is a very old one-room frame structure without vestibule. 15x28 in dimensions, located on a lot approximately 30x100 ft. in a pine woods. The building is in a very bad condition and not suitable for improvement or worthy of consideration or enlargement. It is heated by a common wood stove which has a sheet metal jacket.

It is poorly kept and the outhouses are poor in quality and insani-
tary in condition. The class room is the traditional four wall affair,
with absolutely the minimum of equipment. The glass area is low
and distributed on the left, right and front of the room. The nine
square feet of blackboard space provided is to serve 30 pupils.
Such a situation can call for but one recommendation, that being the
speediest possible abandonment of the site and building for school
purposes.
